Leviathan Mine Site
Interim Combined Treatment
Upper Pond Conveyance System (UPCS) Project
Daily Report
April 24, 2017

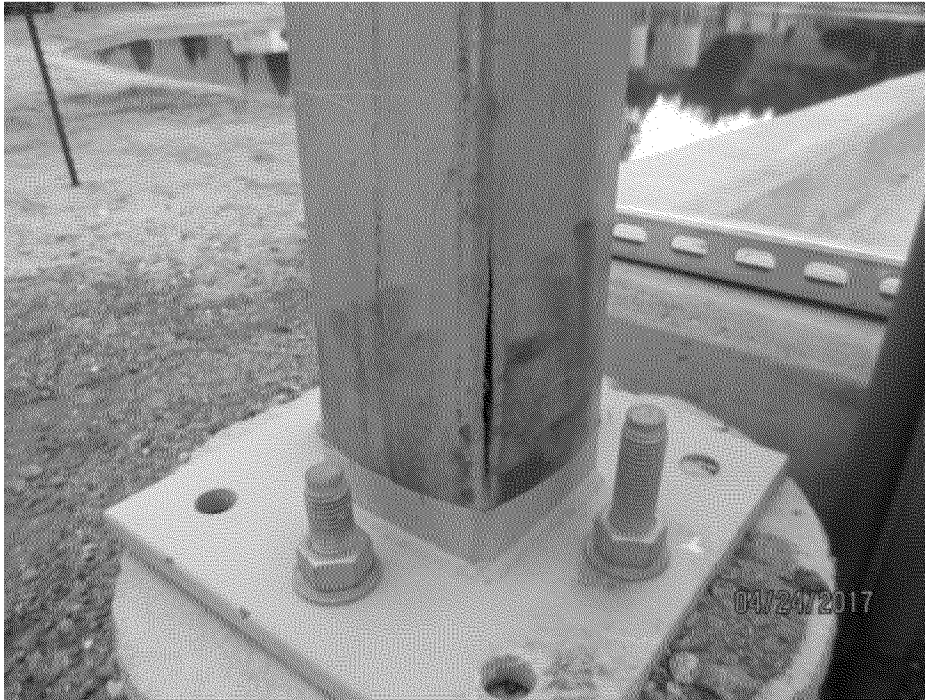
- Water has entered the interior of the control panel steel support pedestals, froze, expanded, and caused swelling of the steel supports near the base. The north pedestal at Pond 1 has cracked at the corner of the pedestal (see photos). Tops of pedestals need to be capped or weepholes added to prevent water from entering the interior. Steel support repair need to be determined by control panel vendor.

Pond 1 control panel steel support pedestal (cracked north pedestal).

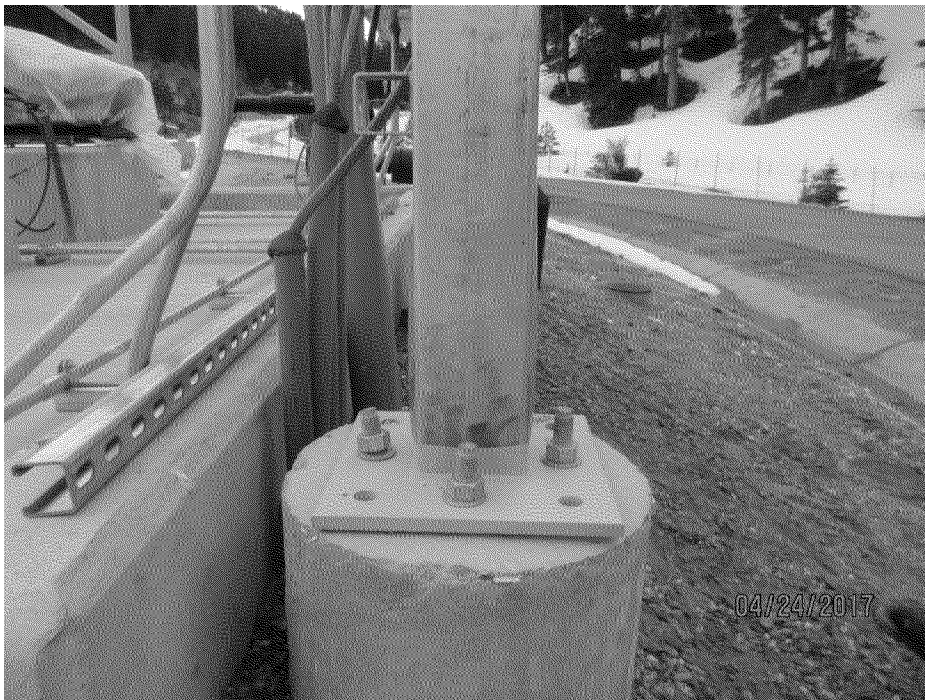
Swelled control panel steel support pedestal (at base).

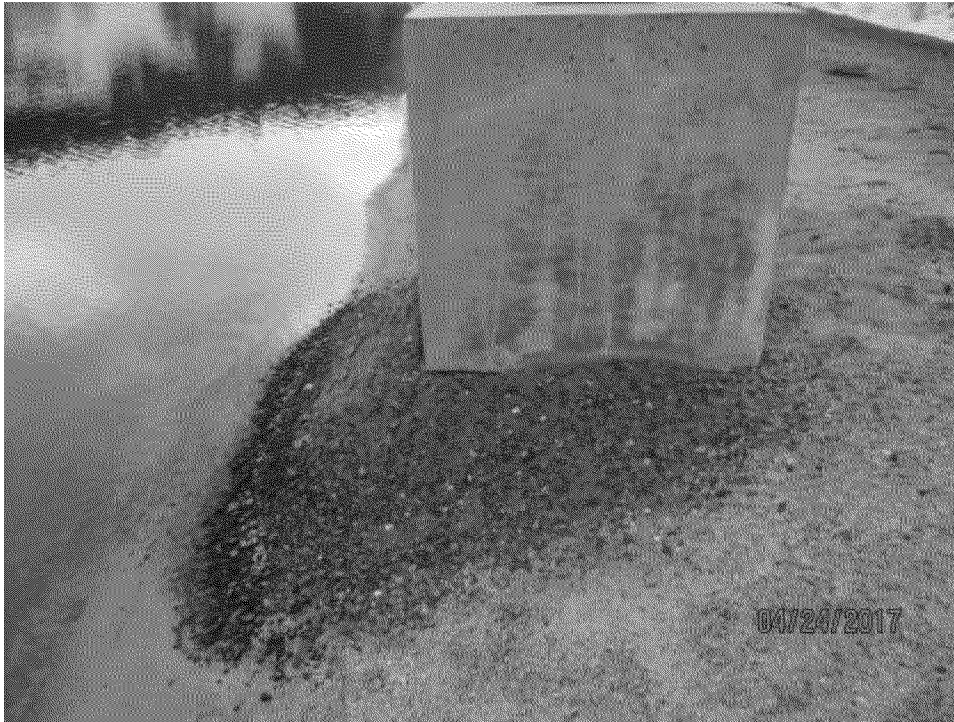
- Winter shutdown issues:
 - Base material under winch concrete pedestals has eroded/settled at the pond-side corners (see photos). South pedestal at Pond 1 appears to have tilted approximately 3 degrees toward pond. Other 3 pedestals at ponds do not appear to show signs of movement.

Eroded/settled foundation material at winch support (Pond 1 south).

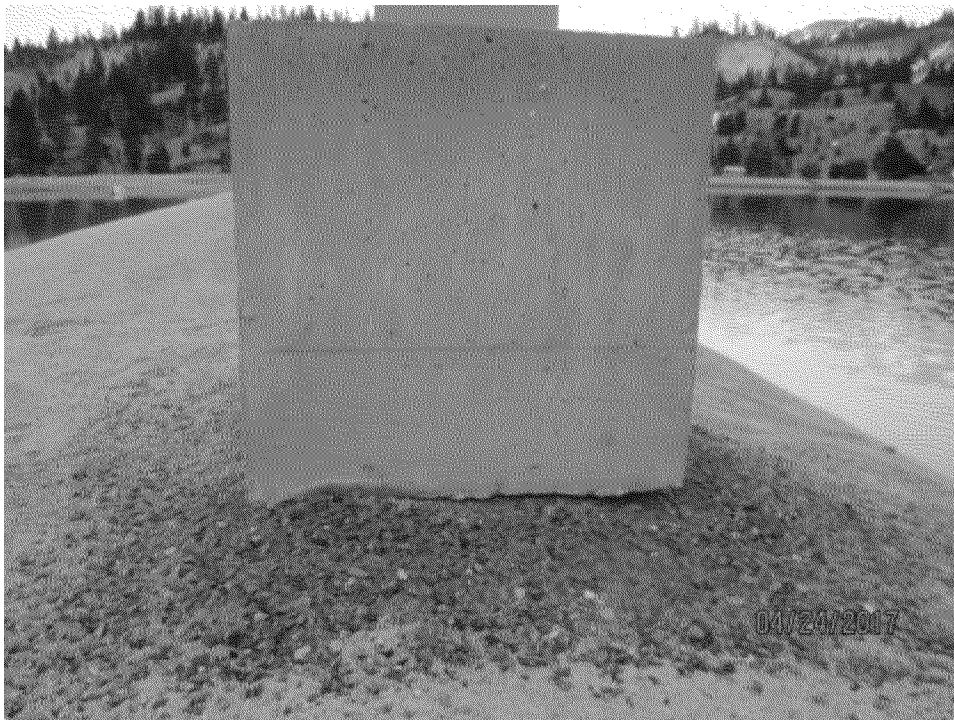
Eroded/settled foundation material at winch support (Pond 2S west).

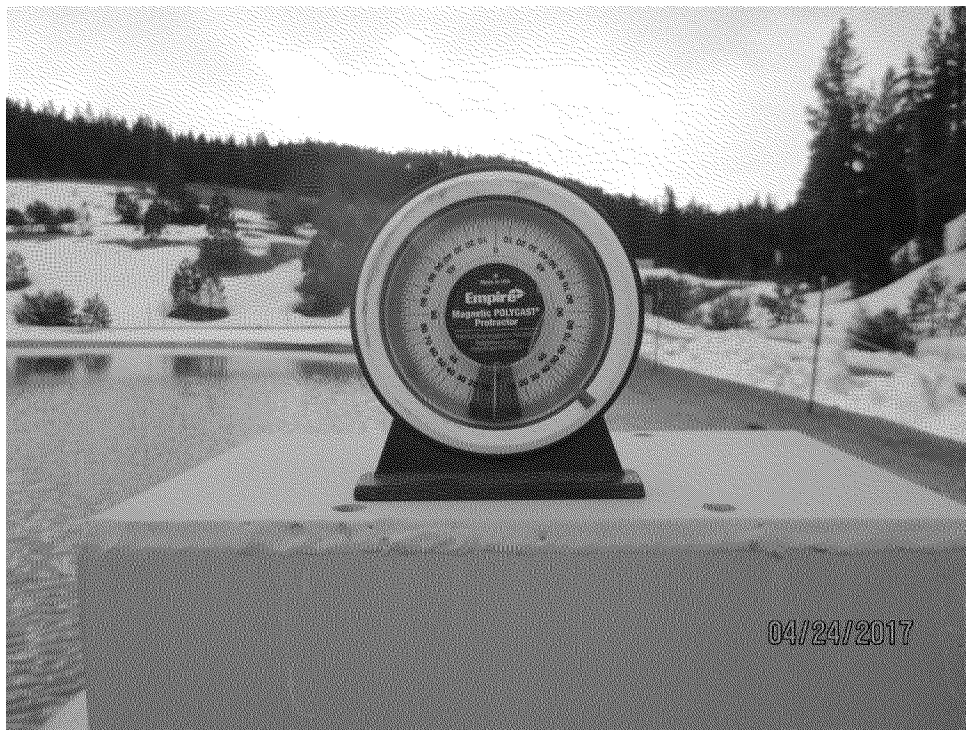
South winch pedestal at Pond 1 is tilted ~3 degrees toward pond.

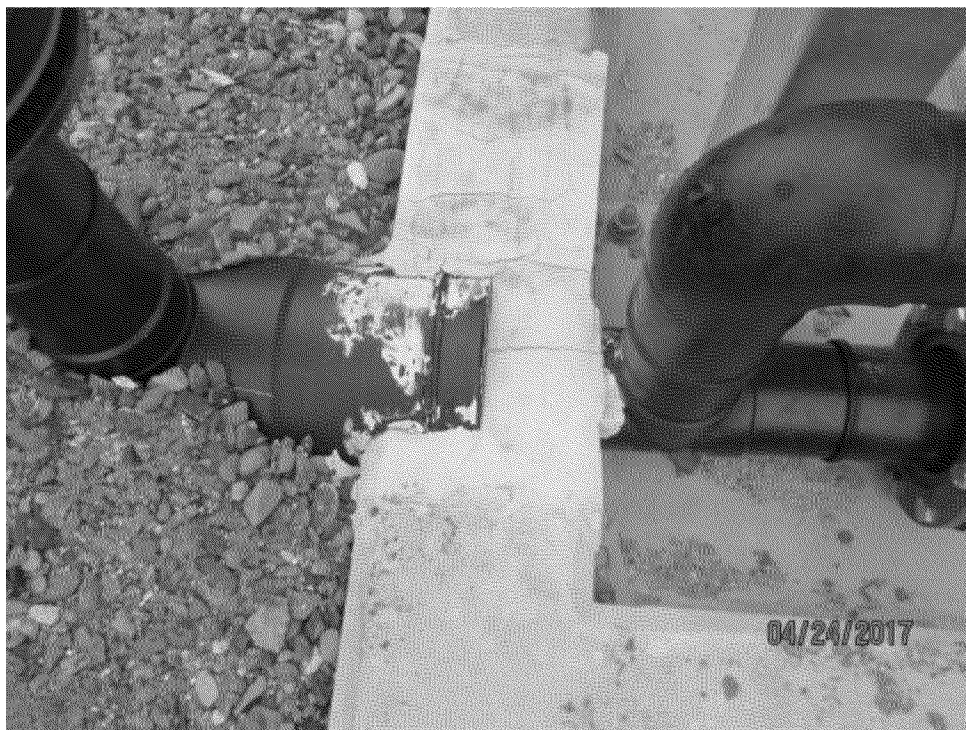
- Grout around discharge pipe at Pond 2S is cracking (see photos). Will need to be replaced/repaired.
 - Earthen pipe anchors along west side of Pond 4 are eroding and allowing minor pipe movement (see photos). Earth anchors need to be repaired or re-built with additional or potentially less erodable material.

Cracked grout around Pond 2S pump station discharge pipe.

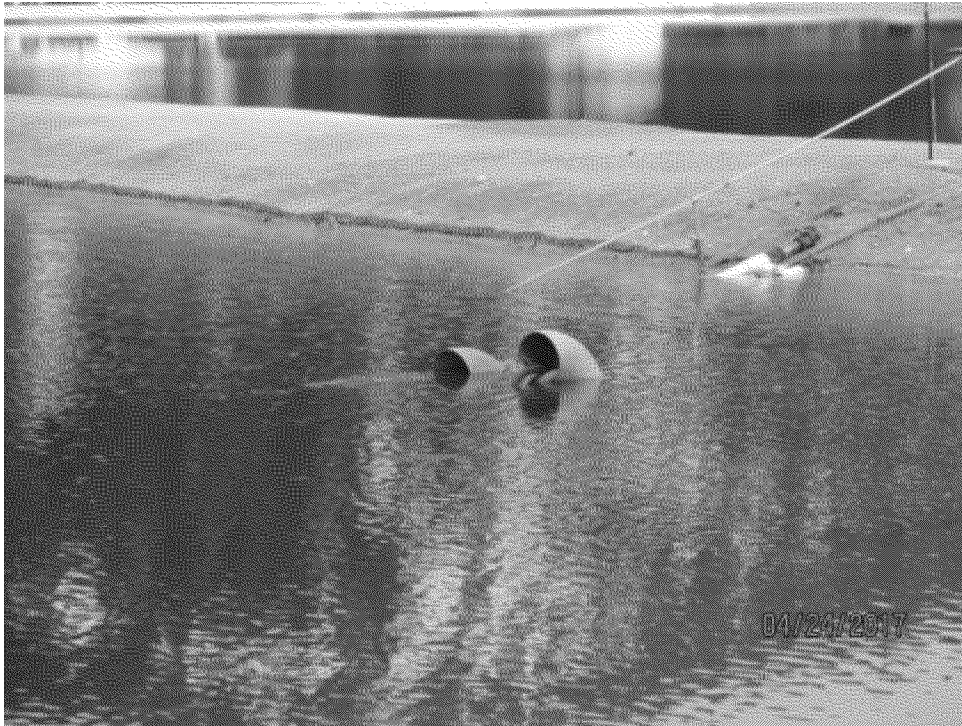
- Ponds 1 and 2S discharging through overflow pipe.

Pond 2S discharging through overflow pipe.

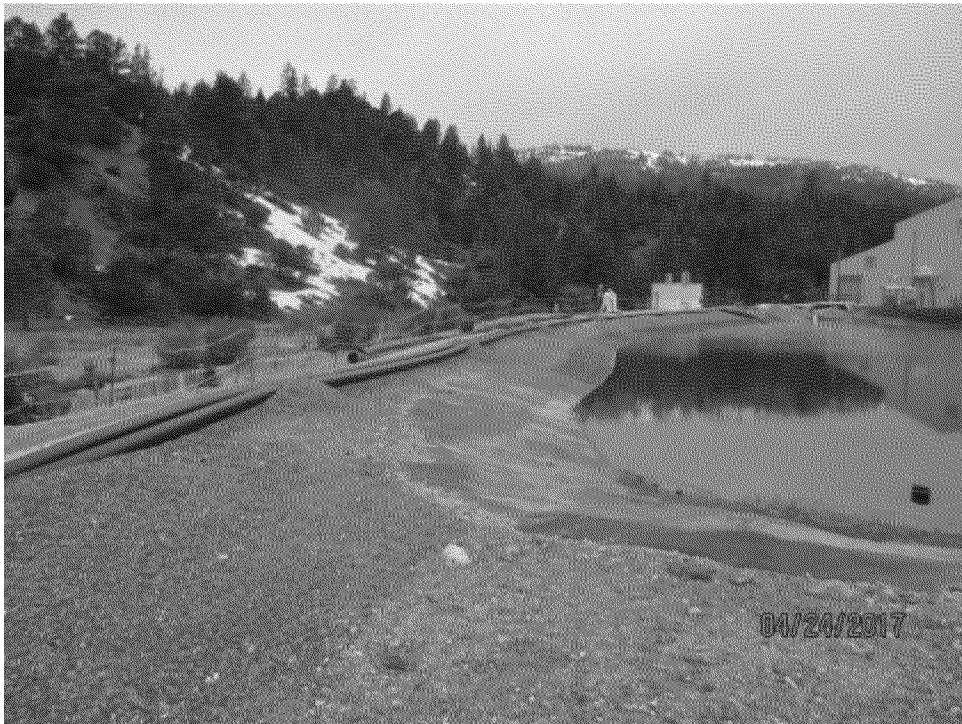
Eroded earthen pipe anchor west of Pond 4.
